## CENTRAL INTELLIGENCE AGENCY

SUBJECT Port Facilities, Activities, and Ship Sightings at Novorossiysk

SUBJECT: The Port of NOVOROSSISK

SUBJECT: Port of Novorossiysk

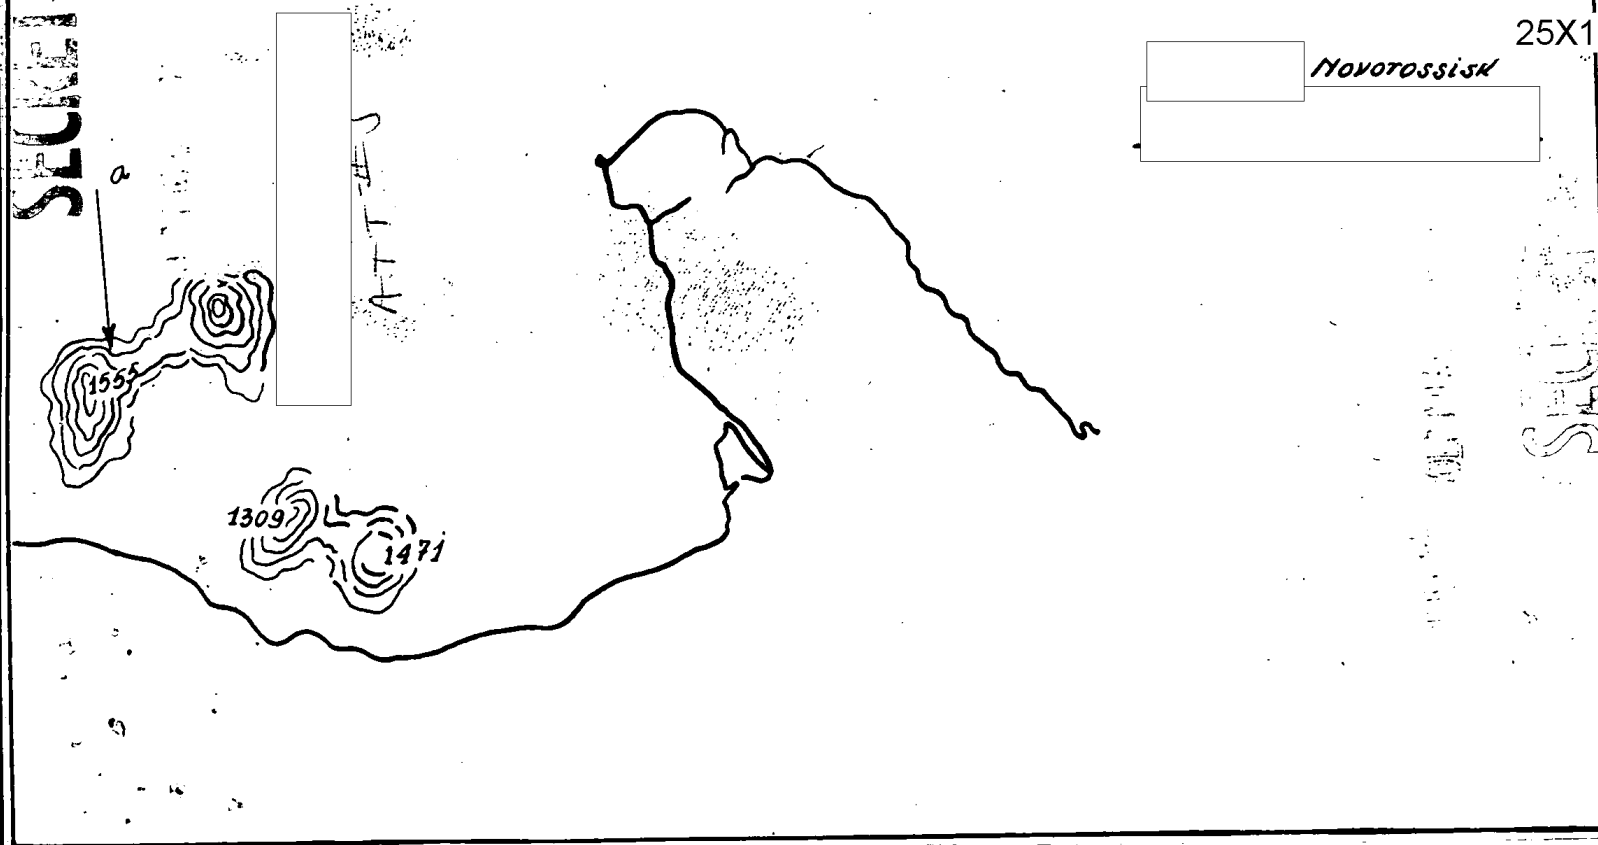
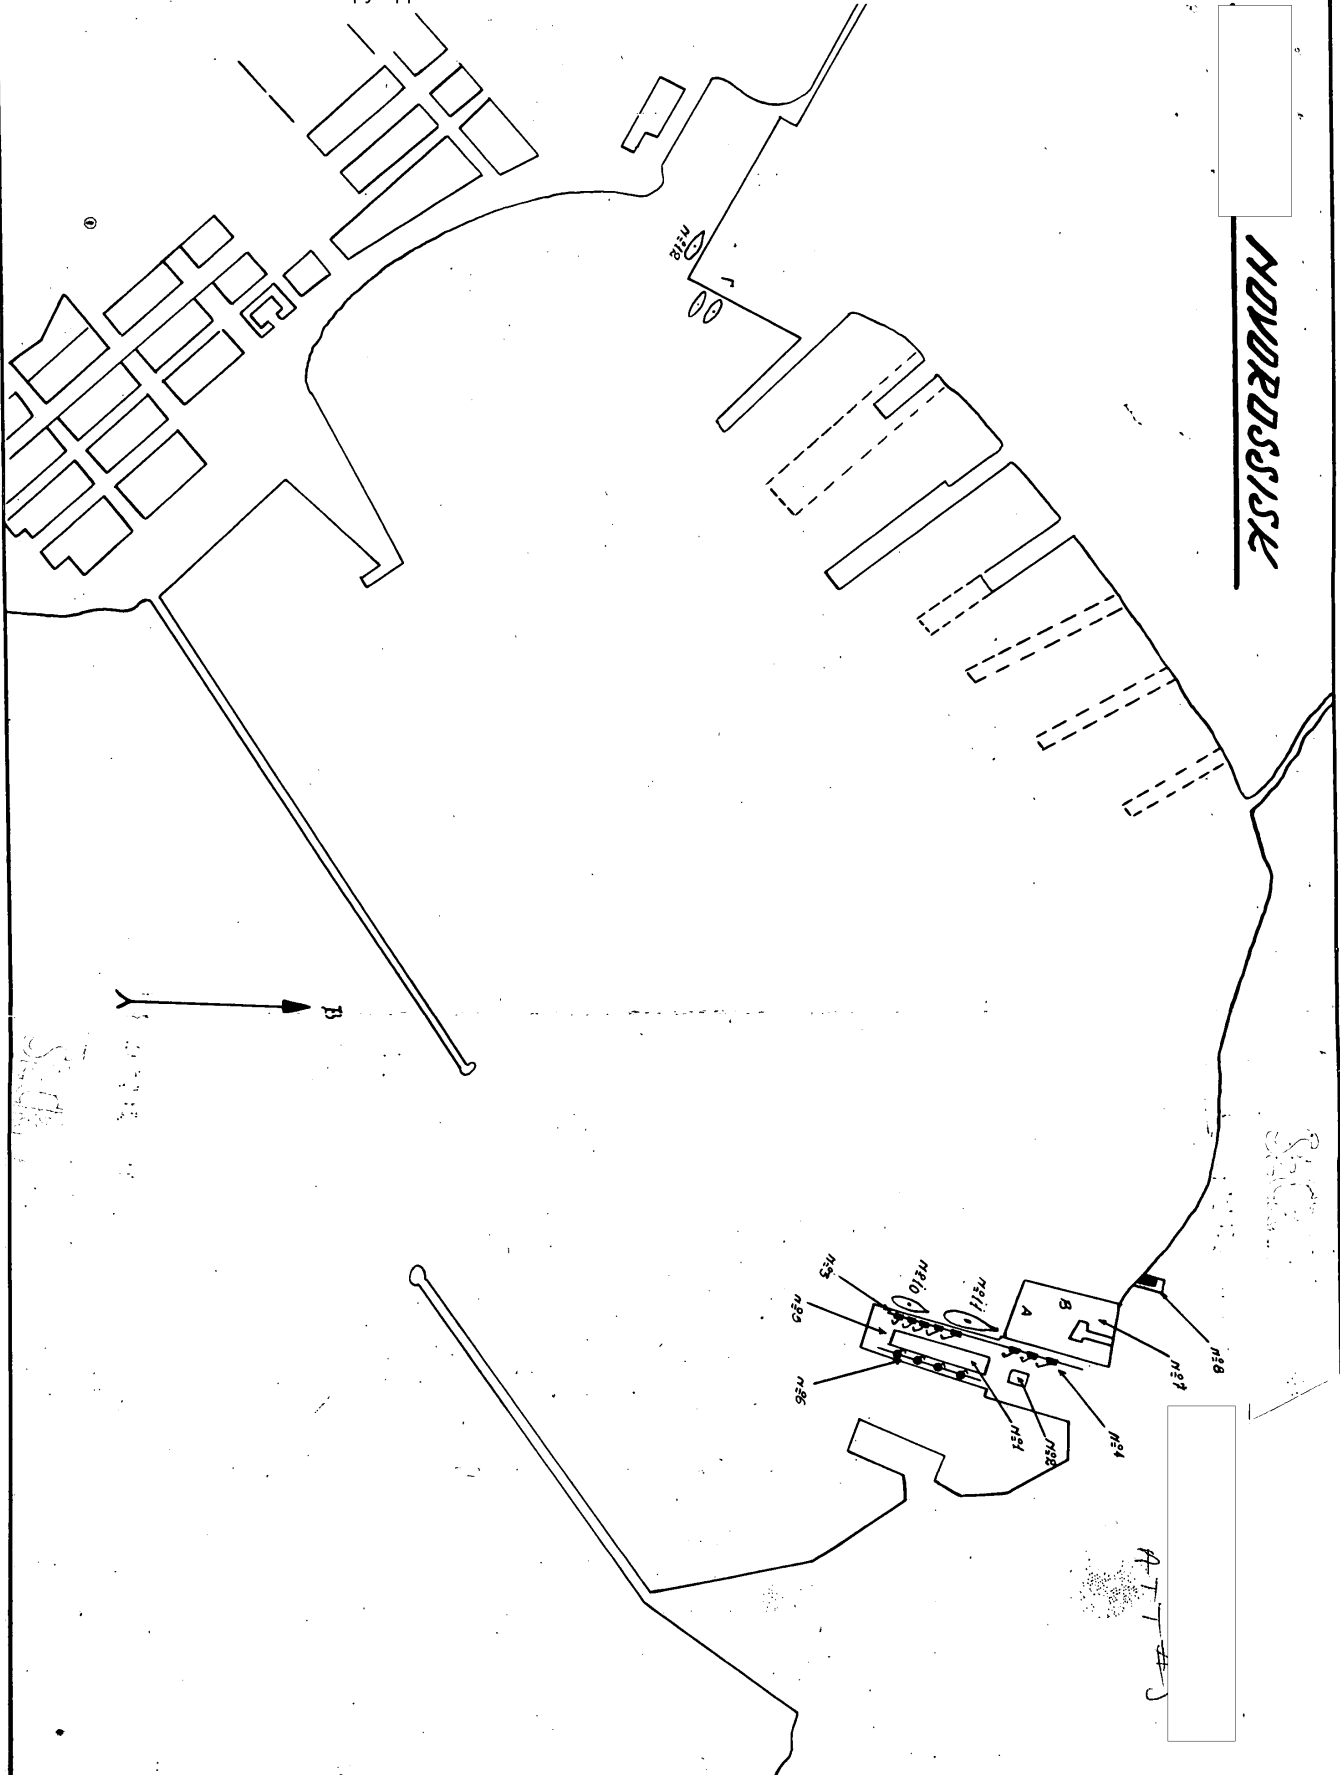
*NOVOROSSISK*

I. ORGANIZATION. (see drawing attached).-

1. Group of warehouses.
2. Office handling ore loadings and unloadings.
3. Five electric cranes of 45,000 kgs. each, bearing a sign with the word BOSTON on it.
4. Three cranes of approx. 30 tons each, used for the arranging of cargoes on the mole.
5. Position for storing coal for supply to small vessels.
6. Three or four cranes, one of which was a 30-ton one, while the others were 45-ton ones.
7. Brand new concrete mole. The sea on the eastern side of this mole, is not very deep.-

### IV. RADARS (see attached drawing No. 2).-

A netted antenna of a Radar was observed at point (a) on the third hill of the western coast in front of the NOVOROSISK port, at elevation 1155 shown on Russian Map No. 6936. The Radar is visible from the harbor as well.

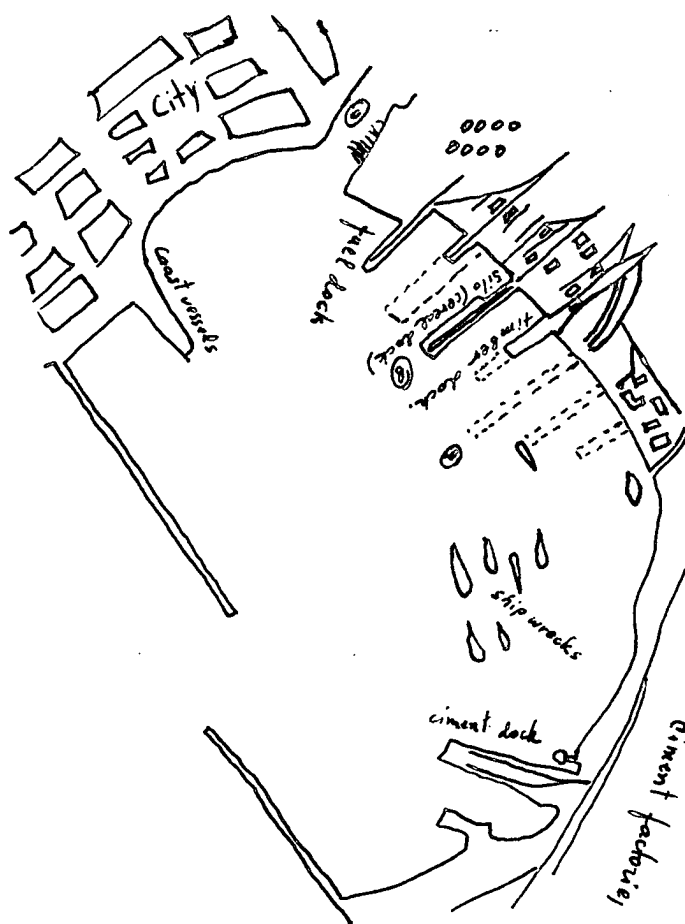
Repair work is being done on the destroyed mole which is marked on the drawing by letter (a).-

There is a pilot station on the mole where the silo is, marked on the drawing by letter (b).-

There are fuel tanks in the harbor, shown on the drawing. 6-7 of them, painted dark lead, are visible. Ships can bunker at the rate of 150 tons per hour.-

The railroad tracks of the harbor, are those shown on the drawing. Same are laid above ground level, not on the ground.

3 medium size destroyers were there noored by the stern at point (c) on the drawing. Same had one funnel painted grey and the Russian flag (a hammer and sickle and a star on white cloth). Same bore a gun on each end - stern and bow. They also bore a gun, smaller in size than the others, above the sternal gun.-

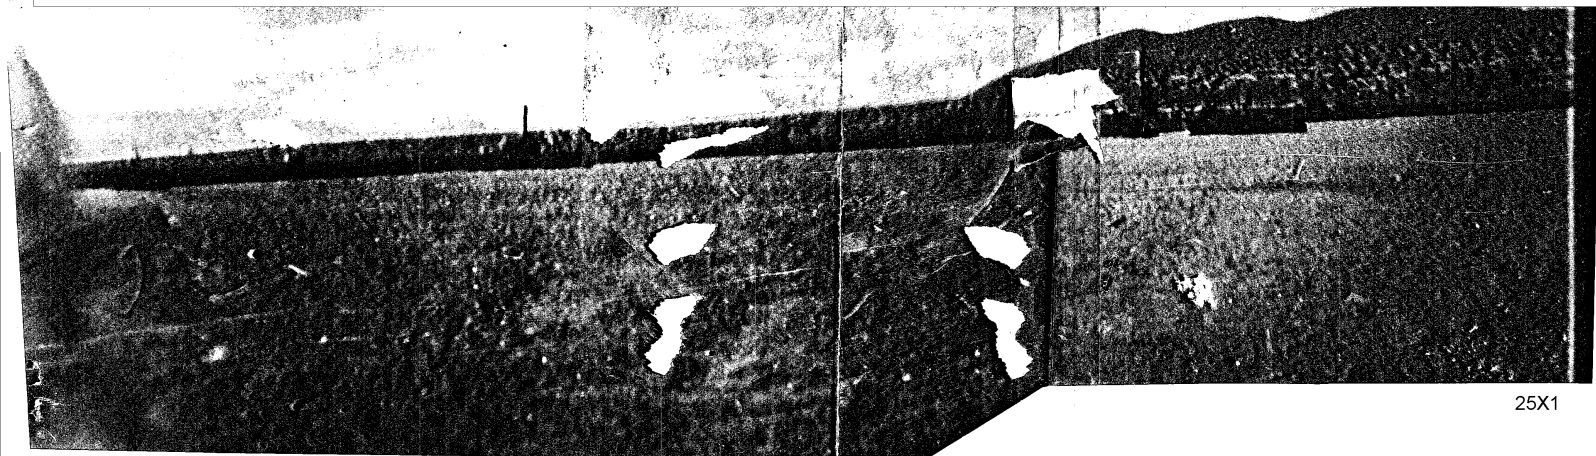
18N USSR S. EUROPEAN RSFSR KRASN Sanitized Copy Approved for Release 2010/03/01 : CIA-RDP80T00246A032900320001-1 ASNODAR KRAY NOVOROSIYSK  
44 43 N 37 47 E PART OF SOUTHWEST MOLE. PART 1 OF 2 PART 44 43 N 37 47 E PART OF SOUTHWEST MOLE. PART 2 OF 2 PART

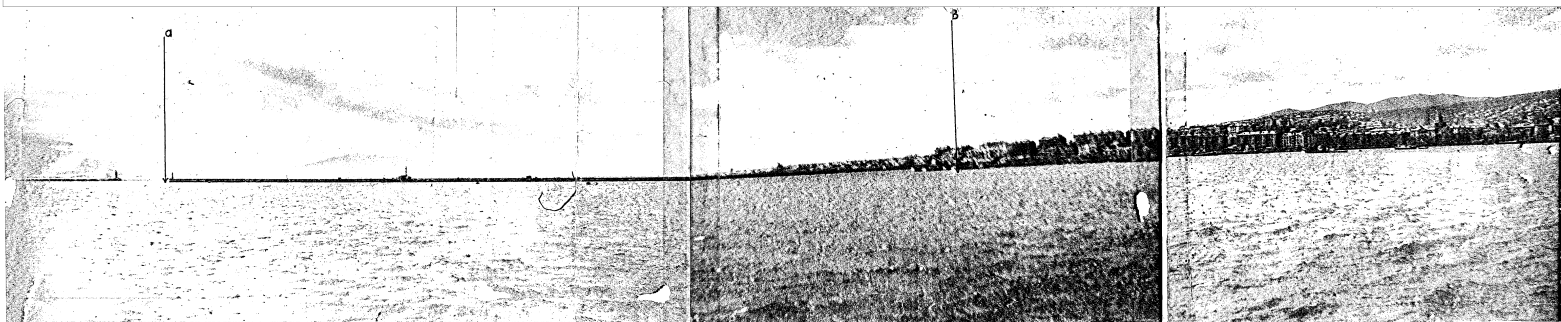
18N USSR S. EUROPEAN RSFSR KRASNODAR KRAY NOVOROSIYSK  
44 43 N 37 47 E SOUTHWEST MOLE. (A) ENTRANCE TO HARBOR.

Sanitized Copy Approved for Release 2010/03/01 : CIA-RDP80T00246A032900320001-1  
18N USSR S. EUROPEAN RSFSR KRASNODAR KRAY NOVOROSIYSK  
44 43 N 37 47 E SOUTHWEST MOLE. (B) DESTROYED QUAY. PART

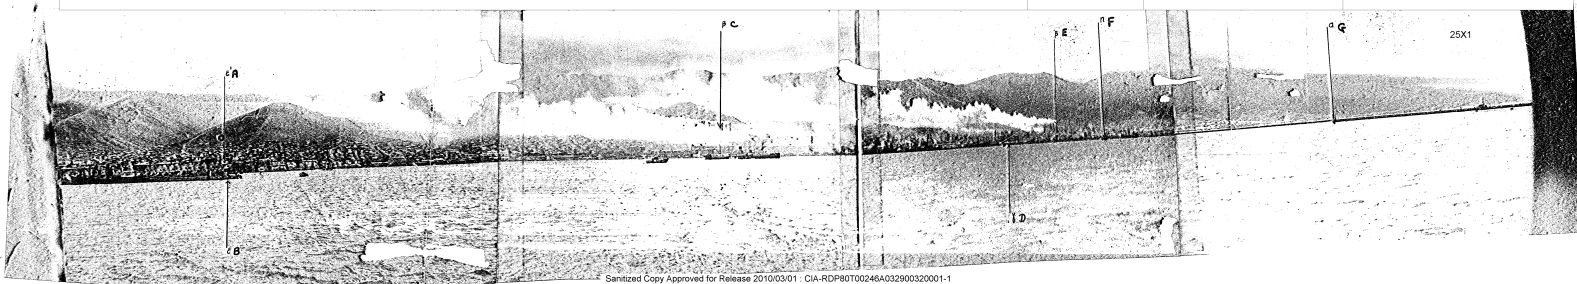
15N USSR S. EUROPEAN RSFSR KRASNODAR KRAY NOVOROSIYSK 44 43 N 37 47 E  
EAST SIDE OF HARBOR. (A)OBSERVATION POST-SEMAPHORE STATION. (B)SHLO QUAY.

15N USSR S. EUROPEAN RSFSR KRASNODAR KRAY NOVOROSIYSK 44 43 N 37 47 E  
EAST SIDE OF HARBOR. (C)CEMENT PLANTS (D)CEMENT QUAY. PART 2 OF 3 PART PANORAMA.

15N USSR S. EUROPEAN RSFSR KRASNODAR KRAY NOVOROSIYSK 44 43 N 37 47 E  
EAST SIDE OF HARBOR. (E)CEMENT PLANT (F)FLOATING DOCK (G)HARBOR ENTRANCE. PART 3
